**FORT CARSON IN WORLD WAR II:
THE OLD HOSPITAL COMPLEX**

By Melissa Connor and James Schneck

**National Park Service
Midwest Archeological Center
Lincoln, Nebraska**

1997

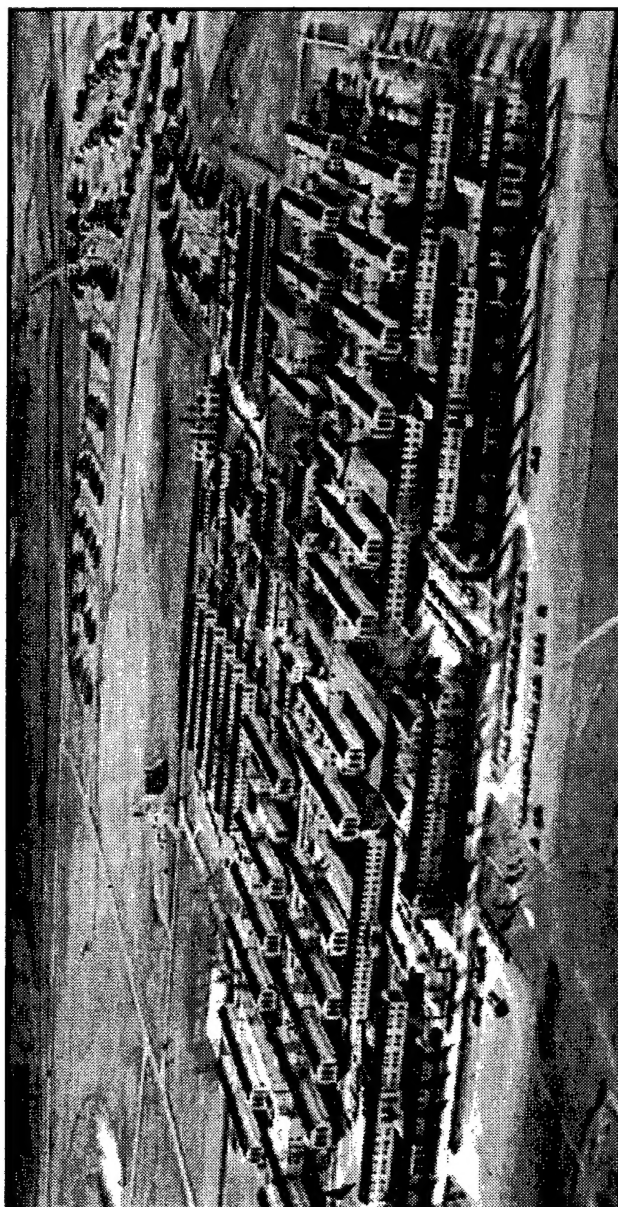
Figure 1. The hospital complex from the air. View to the southeast.

From the air, it's easy to see that most of Fort Carson is laid out in a crescent-shape. The Old Hospital Complex, to the southwest of this crescent, stood out in its rectangular regularity (Figure 1). There were 59 buildings in the complex, most connected by covered walkways. From the ground, the immensity of the complex, covering almost 62 acres, becomes apparent. The buildings and the walkways connecting them were designed strictly for utility, constructed of cinder blocks, and the exterior painted a dirty cream color. The small spaces between the buildings were grassy areas, kept neatly mowed and planted with a few trees.

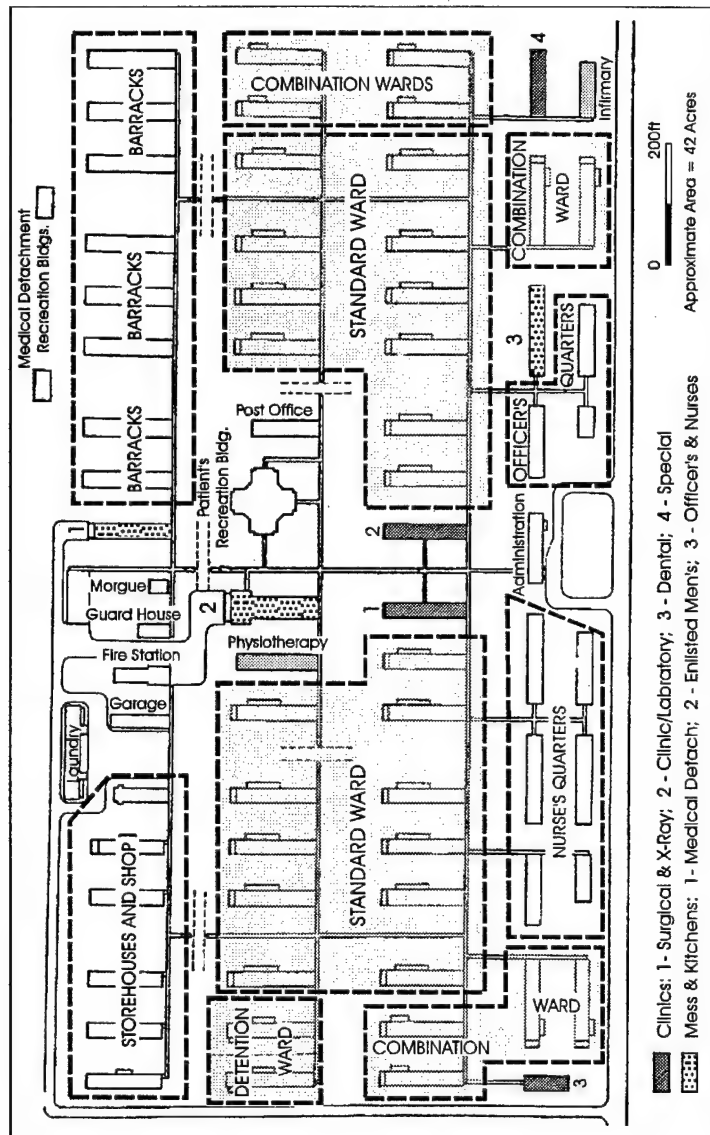
Figure 2. Typical hospital layout as described in a 1941 Army technical manual.

The general guidelines in 1941 for locating and establishing a general hospital can be found in the Technical Manual for Fixed Hospitals of the Medical Department published in the summer of 1941 by the War Department. The manual shows a typical layout for a 1,000-bed general hospital, which was to be suited to local conditions and needs (Figure 2).

In general, a 1,000-bed general hospital would have 62 buildings: 33 wards, administration, surgical, receiving and forwarding, and bath buildings, messes, and personnel buildings. The manual specifies three types of wards: combination, standard, and detention. The combination ward has 26 beds, 10 of which were private and 16 in an open ward. Wards of this type provided for the seriously ill, isolation and segregation. Standard wards had 33 beds, with only two semi-private beds and the rest open. These wards were intended for the noncontagious and convalescent patients. The detention ward has 25 beds, 9 private and 16 open. The porches were to be iron-meshed, rather than open. These wards were meant for neuropsychiatric patients and prisoners. In a general hospital of 1,000 beds there were to be 10 combination, 21 standard, and 2-4 detention wards.

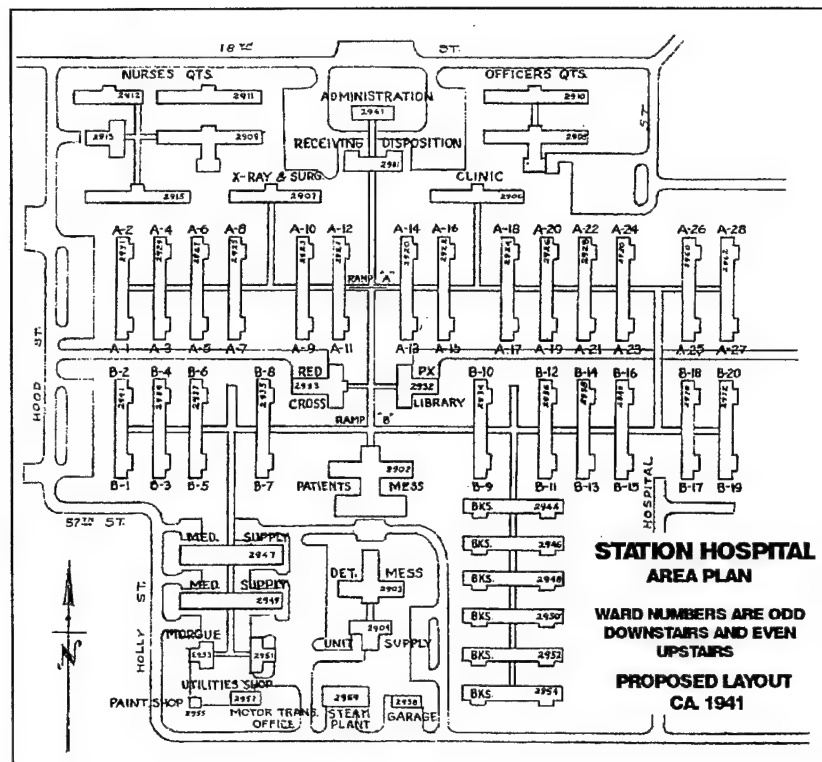
Figure 3. Proposed layout for the Camp Carson Station Hospital showing building functions.

The two-story construction did not halve the number of buildings, but did reduce it. The proposed layout in the technical manual consists of 62 buildings, of which 33 were wards. The hospital complex at Camp Carson consisted of approximately 55 buildings, of which 22 to 24 were originally designed as wards. The general layout of a "typical" 1,000-bed hospital occupied 42 acres. The larger 800 Series buildings allowed hospital patient capacity to triple while occupying only half again as much area. Camp Carson's hospital occupied about 64 acres. By the end

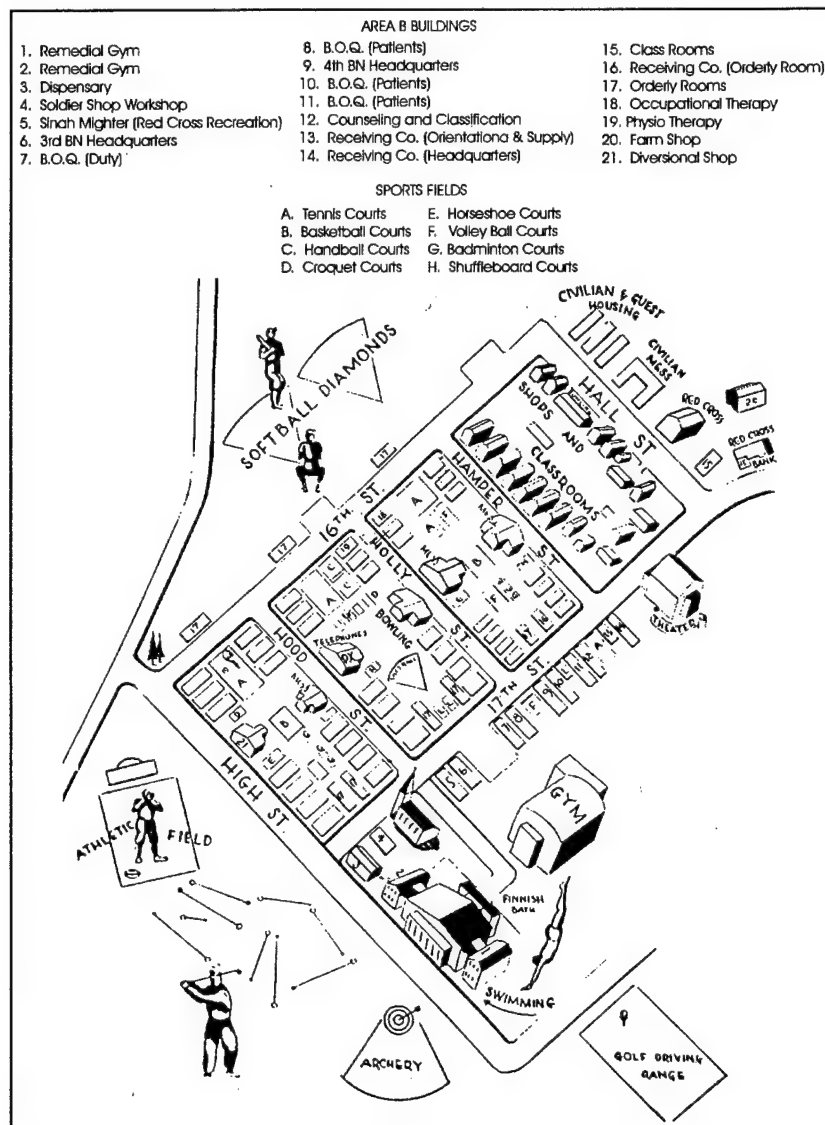
Convalescent Hospital Area B was constructed in 1945 at least partially from 700 Series plans. It housed about 2,400 patients and included three mess halls, a ration breakdown building, post exchange, a clinic, a bowling alley, five gymnasiums, shops, a physiotherapy building, swimming pool, and a Finnish bath (Figure 5). Sports facilities included tennis, basketball, handball, croquet, horseshoe, volleyball, bad-

Figure 5. Convalescent Hospital Area B. From *Carson's Record is Proven: Hospitalization in Nature's Most Healthful Climate..and Morale-Building Environment*. Manuscript on file in the Local History Collection, Pikes Peak Library District, Colorado Springs, Colorado.

minton, and shuffleboard courts. Only one gymnasium (Building T-6049, site 35EP2444) and the theater (Building T-6120, site 5EP2445) were of cinder block construction.

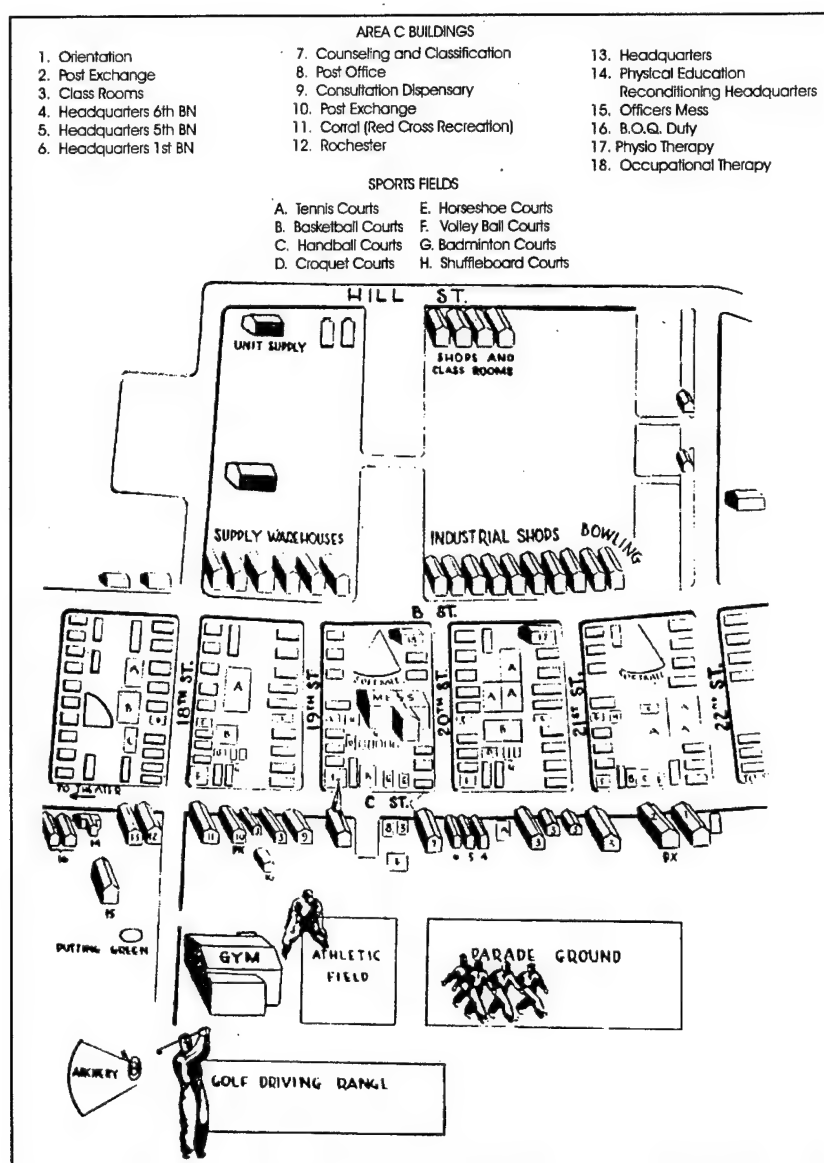
Convalescent Hospital Area C was also constructed in 1945 at least partially from 700 Series plans. The Iron Horse Gym (Building T-1843, site 5EP2441) is one of the few buildings from the convalescent center still extant. Originally, the center included an orientation building, a post exchange, classrooms, a counseling and classification building, a post office, a consultation dispensary, a Red Cross building, a physical education reconditioning headquarters, a physiotherapy and an occupational therapy building, as well as quarters and a mess (Figure 6). Sports facilities included the gymnasium, and areas for tennis, basketball, handball, croquet, horseshoes, volleyball, badminton, shuffleboard, golf, and archery.

Figure 6. Convalescent Hospital Area C. From *Carson's Record is Proven: Hospitalization in Nature's Most Healthful Climate..and Morale-Building Environment*. Manuscript on file in the Local History Collection, Pikes Peak Library District, Colorado Springs, Colorado.

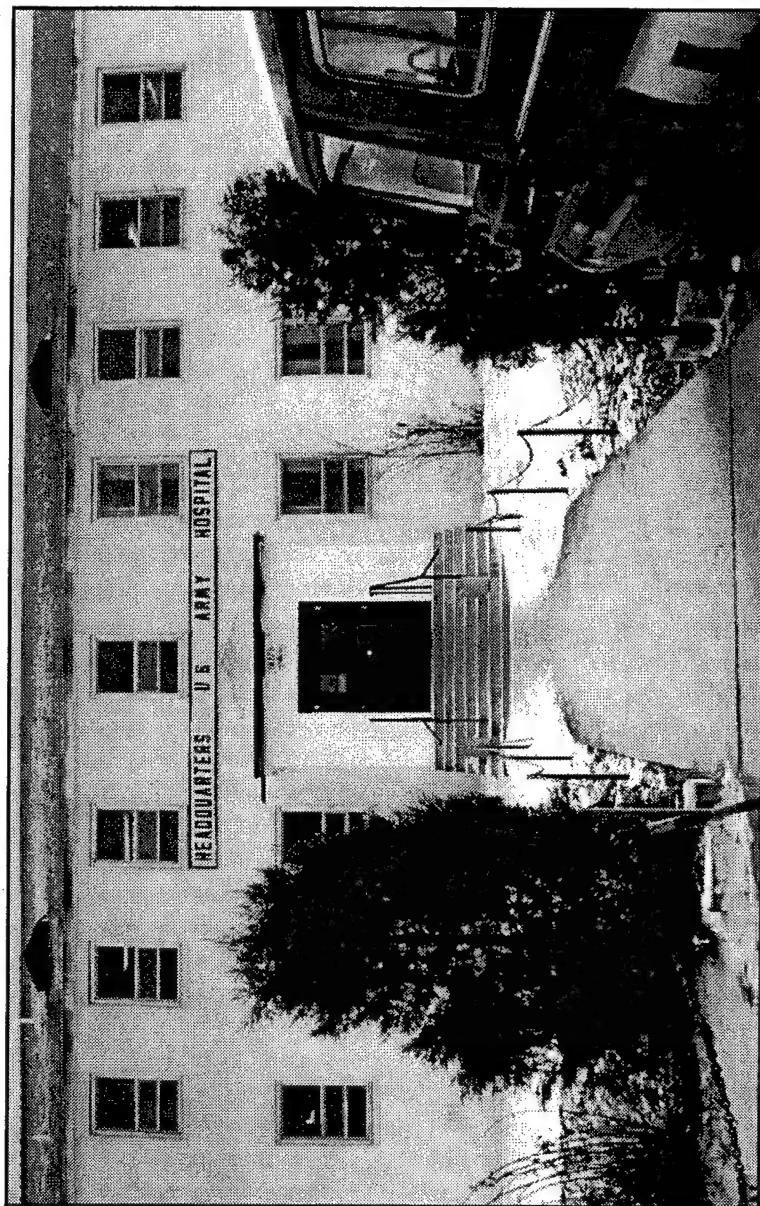
Figure 8. Undated photograph of the Administration Building (Building S6225) taken during the building's tenure as post headquarters.

The two buildings are similar in their location, construction, and simple, two-story appearance. However, the Administration Building has typical cinder brick sills while the Administration and Receiving building sports red clay brick sills. And, the interior of each building was quite different. The Administration Building was constructed

as a simple rectangle filled on both floors with large office rooms. Later wings added several additional offices at both ends of the building. Still more office rooms were added with an extension of the wings. According to Army records, this building has always been used as an Administration General Purpose building. At various times the building has housed the Hospital Headquarters, Post Headquarters, Medical Administration facilities, a pharmacy, and offices for Plans Operations Training and Security.

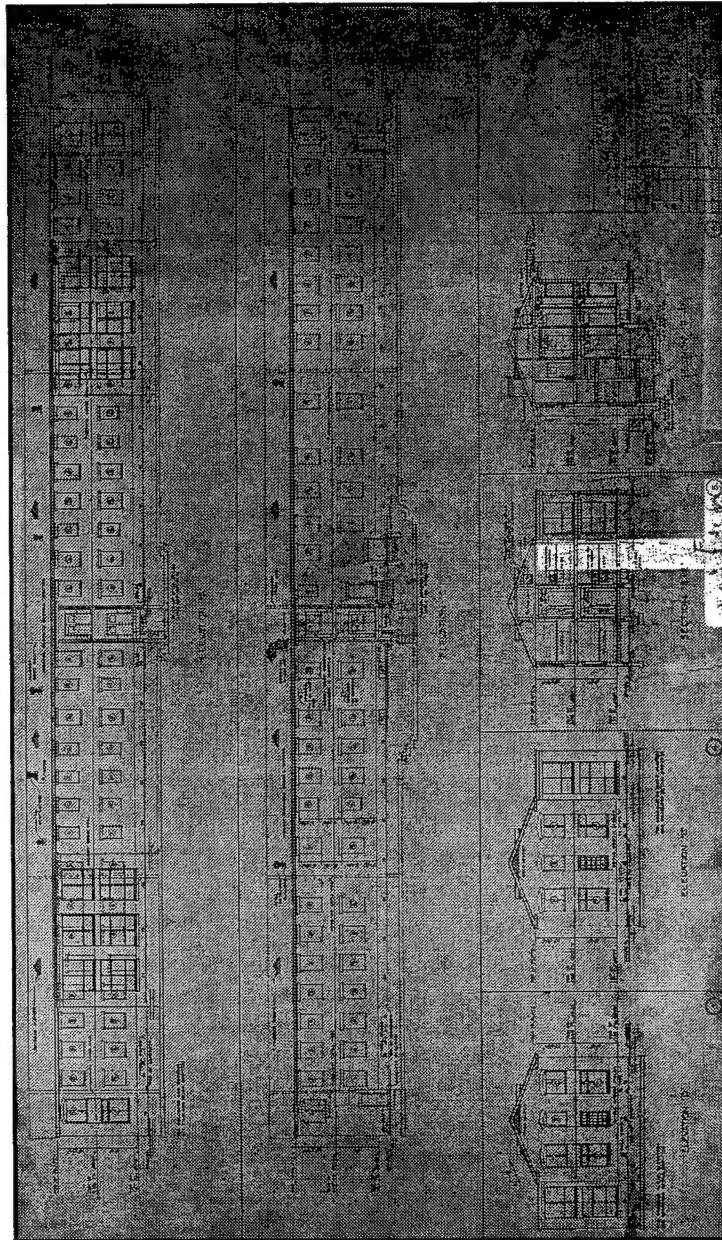
Figure 9. Elevations and sections for a neuropsychiatric ward (Building S6253).

All wards originally had the same massing, construction, and basic layout. All were narrow, two-story, cinder block buildings (Figure 9). A typical layout consisted of doubly loaded corridors flanked by utility, service, and patient rooms. The corridors terminated in large common-ward rooms overseen by a windowed observation room. Sun rooms and

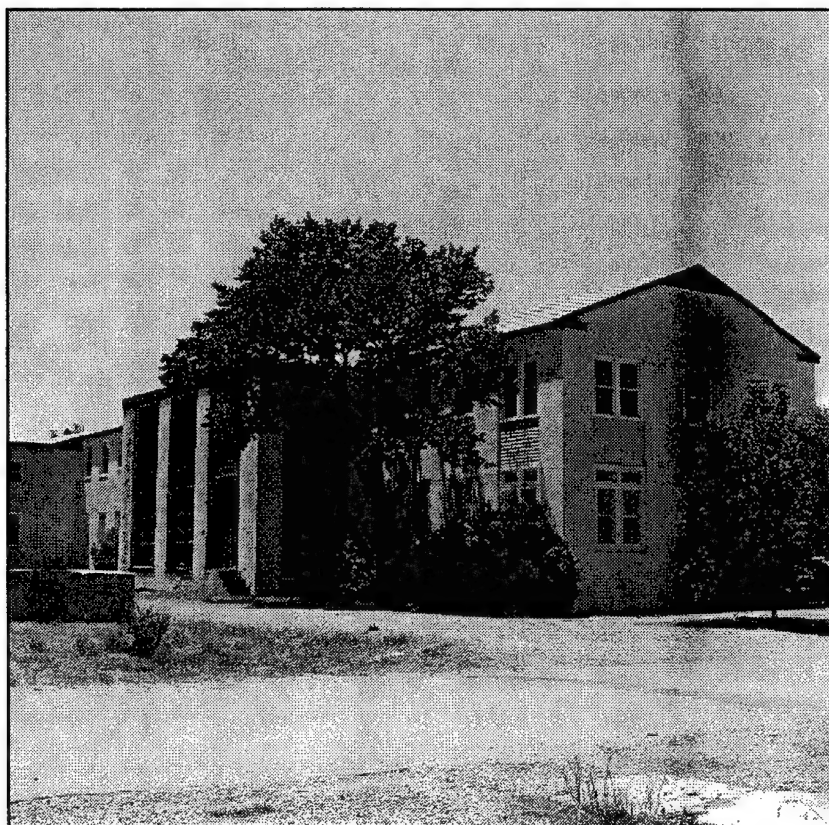
Figure 10. View of a neuropsychiatric ward (Building S6253) showing the screened porches accessed from the common-ward rooms.

porches were accessed from the common-ward rooms (Figure 10). Each floor of each building operated independently, and each contained its own medical personnel office(s), examination and treatment room(s), kitchen, and linen and utility rooms.

The neuropsychiatric wards were highly secure areas and sometimes functioned as wards for ill prisoners such as those from the Prisoner of War Camp at Fort Carson. These wards were completely self-contained. Patients slept, recreated, dined, and were treated all within the same walls. Control elements such as compartmentalized spaces and windowed observation rooms that have security glass with wood or metal shutters are fairly obvious. So are the observation windows within heavy metal doors that could be covered with metal plates, operable on only one side. Windows and entrances were sealed with expanded metal mesh.

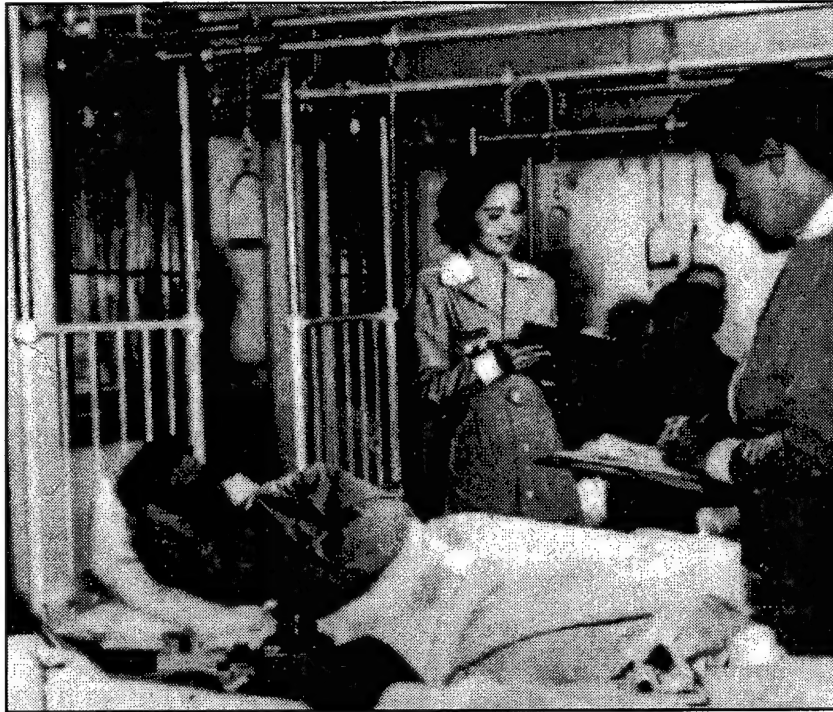
Figure 11. Interior of a World War II hospital ward; location unknown.

The differences between the ward types were more pronounced. Standard wards could accommodate up to 48 men in open-ward rooms (Figure 11) and five men in private rooms, per floor. The open-ward rooms of the standard wards were the largest of the ward buildings. Combination wards held 36 men in open wards and ten in private rooms, per floor. Neuropsychiatric wards held 36 men in open wards and five in private rooms, per floor. Special wards held 24 men in open wards, 12 in private rooms and two in semi-private rooms, per floor. Only the special wards contained semi-private rooms each with call buttons (Figure 12). All private bathrooms had a toilet, sink, and bathtub or shower, but only the private and semi-private rooms of the special and combination wards had private bathrooms. Each of the neuropsychiatric ward floors contained its own dining room. These wards also incorporated additional internal and external security measures not seen in the other ward types.

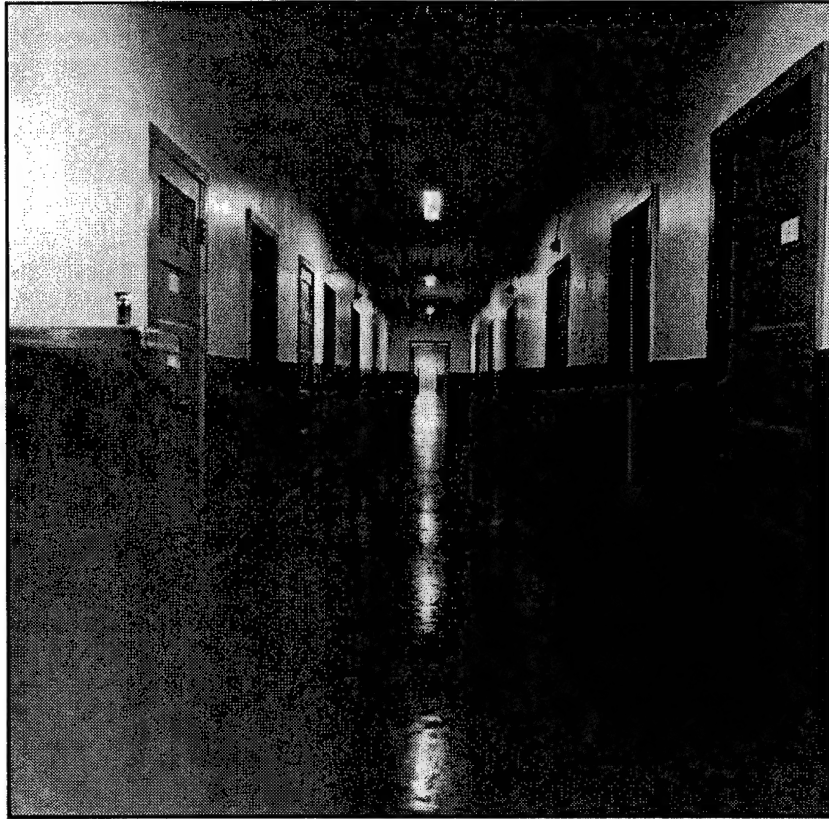
Figure 12. Interior view of a special-ward second-floor hallway (Building S6262). Note the call lights over the doorways to the patients' rooms.

Seven buildings were built as special wards. Both floors of these two-story buildings were identical, accommodating 12 patients in private rooms, two patients in a double room, and another 24 patients in open wards that sat at the ends of the corridor. Each floor also had offices, clean and dirty linen closets, utility rooms, general patients' bathrooms, an examination room, and a kitchen.

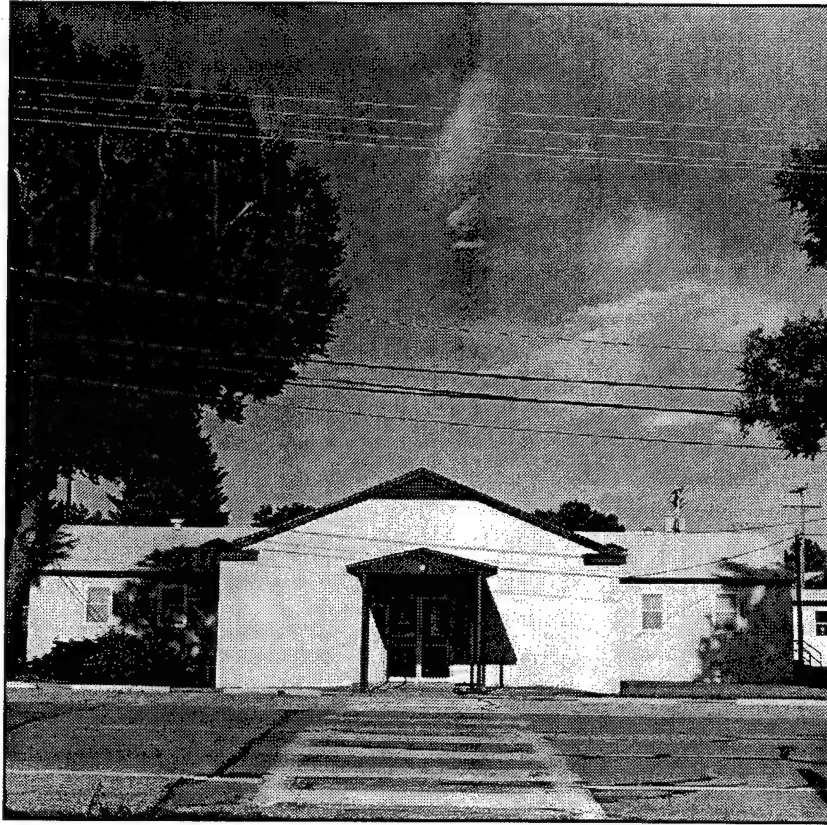
Figure 13. Nurses' Mess and Kitchen (Building S6221). West view of building.

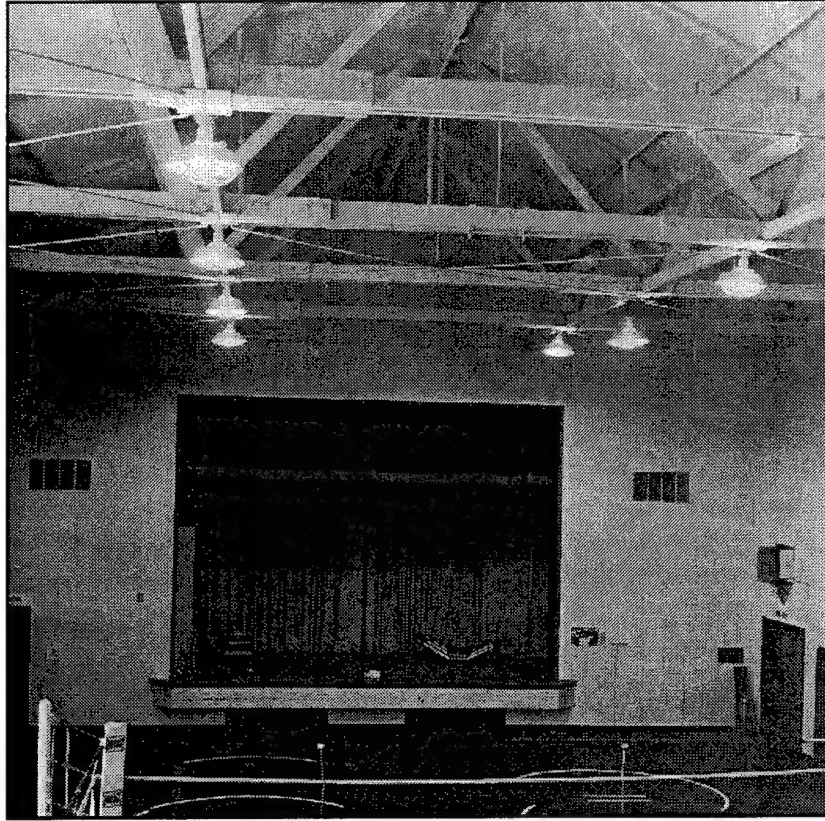
The Patients' Recreation Building originally incorporated a 500-seat theater that accommodated both film and live performances (Figure 14), a reading room, a stenographic room, recreation staff offices, and quarters for up to 14 personnel. The building also housed Red Cross offices and quarters and was known as the ARC in reference to the American Red Cross acronym.

Figure 14. The Patients' Recreation Building (Building S6251). Recreational activities included theater programs.

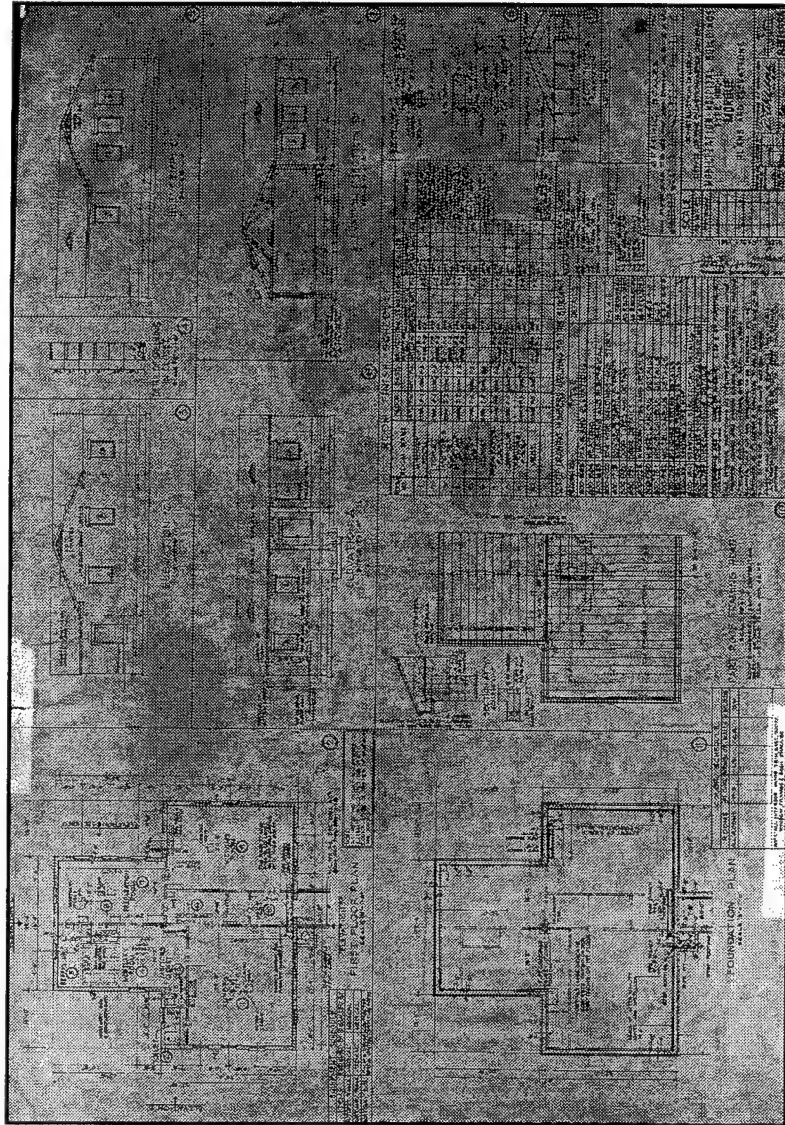
Figure 15. Plans and elevations for the hospital morgue (Building S6273).

The Morgue (Building S6273) was a one-story building containing autopsy, viewing, preparation, and mortuary rooms, as well as a small janitor's closet and one-stall bathroom (Figure 15). The building was used as a morgue until 1992, so the interior of the building was relatively well preserved when this project was underway.

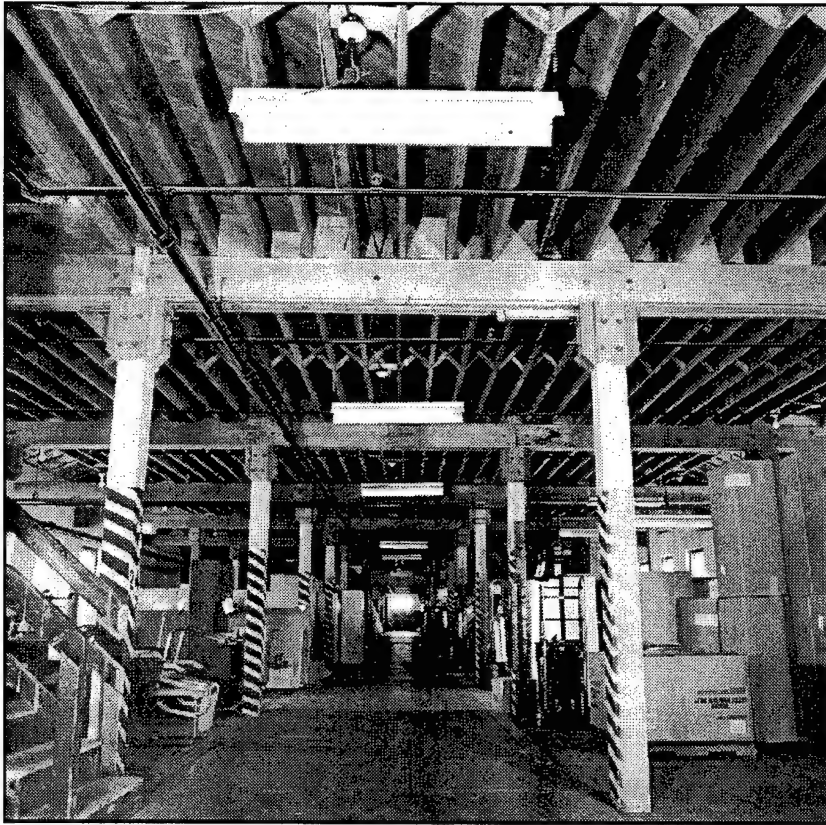
The two storehouses (Building S6270 and Building S6271) were constructed from different plans, but have identical exteriors. Both are rectangular and basically symmetrical. Their 51' widths distinguish them from the 32' 4"-wide ward buildings. Building S6270 contained one large storage room on its first floor and two more in the attic. The first floor also contained several smaller storage rooms, bathrooms, three offices, soiled and clean linen rooms, two vaults (one for drug storage), and drug and linen dispensaries. Building S6271 incorporated one of the interior rooms or vaults of S6270. Its spaces were devoted to open storage areas (Figure 16), and its attic floor did extend to the interior wall edges.

Figure 16. Interior of the storehouse (Building S6271).

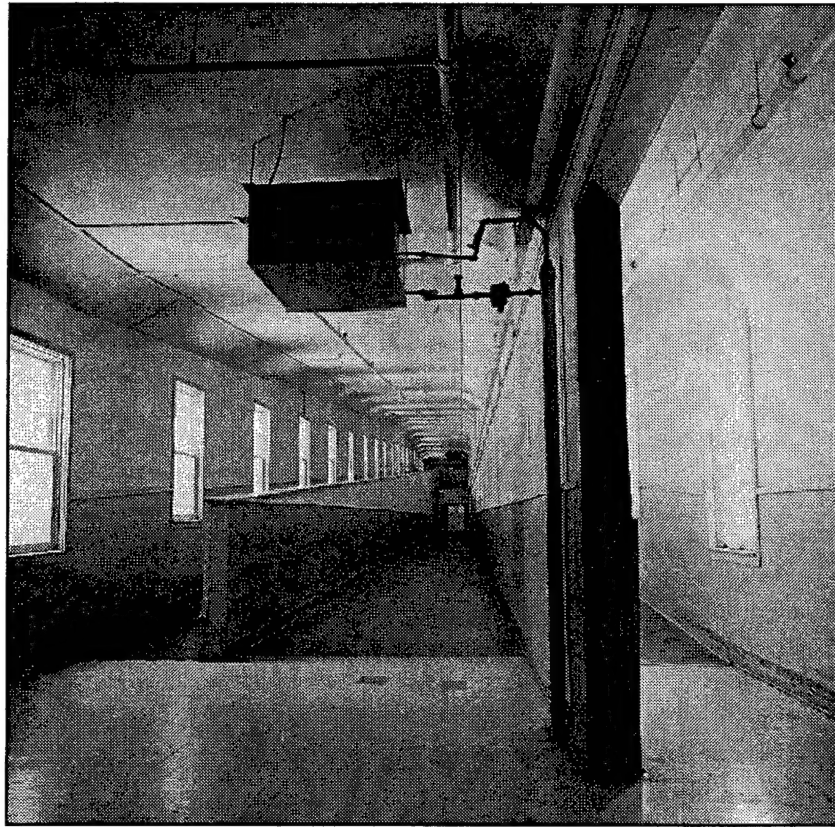
Figure 17. Interior shot of ramp system and double corridor connecting Building S6251 to the hospital complex. The system of covered walkways united the entire complex. The ramp system allowed wheelchairs, gurneys, and supply trolleys to move easily between buildings and floors.

The hospital's system of covered walkways, or corridors, provided sheltered passage between virtually all buildings (Figure 17). The

corridors incorporated ramps that allowed wheeled gurneys and wheelchairs easy access to the second floor. Several types of 800 Series corridors were constructed at the complex. Like the rest of the complex, the corridors are constructed of cinder block. All originally had flat roofs and windows at regular intervals.
